HOME INSPECTION REPORT

4 Heslop St
Ajax

Prepared by: Bob Papadopoulos P.Eng., RHI *

Inspection Date: June 22 2020

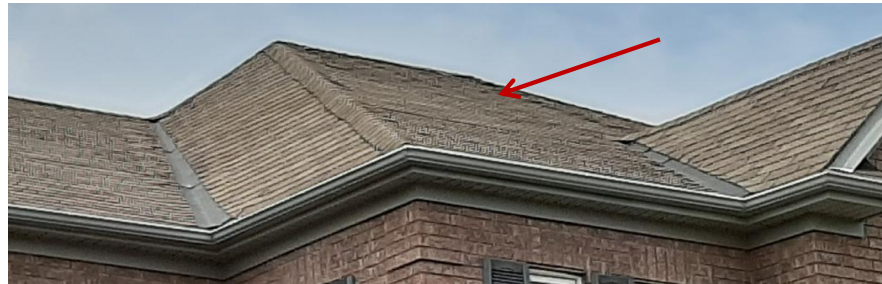
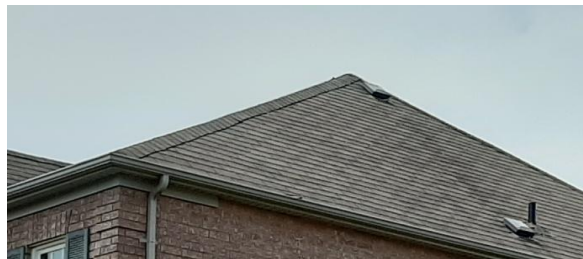
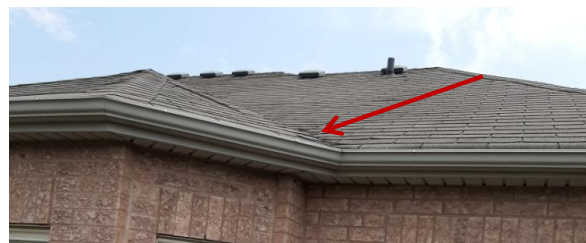
Sloped Surface: areas of shingles are showing signs of aging and will require replacement within the next 2 yrs though overall it might be more cost effective to replace throughout

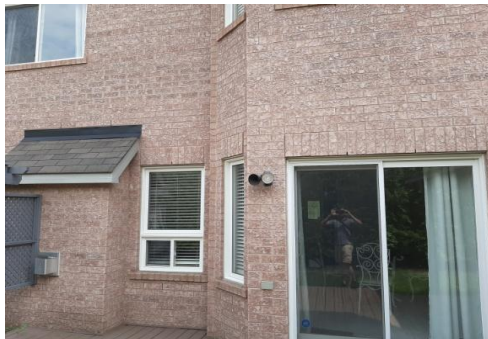
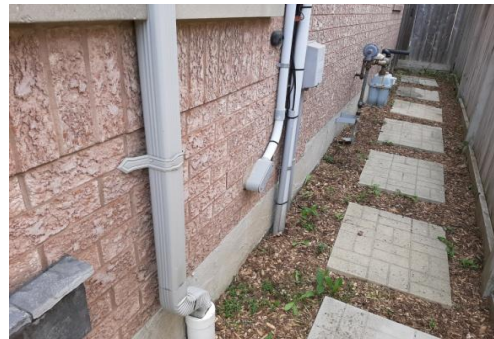
WALL SURFACES: overall in good repair
DOORS/WINDOWS: overall in good repair

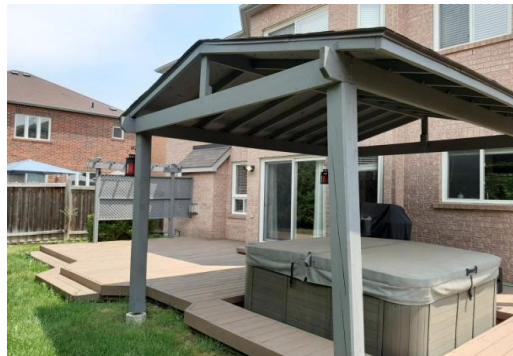
Comments: back yard: roof structure for hot tub requires lateral structural support - safety concern

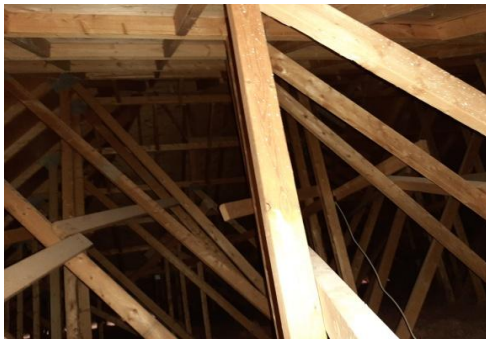
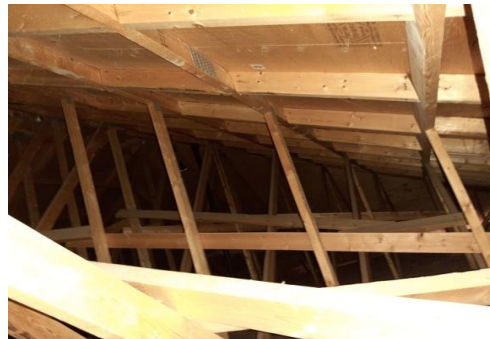
FOUNDATIONS: typical minor settlement cracks
patched cracks in some areas as observed from basement

ROOF: overall in good repair

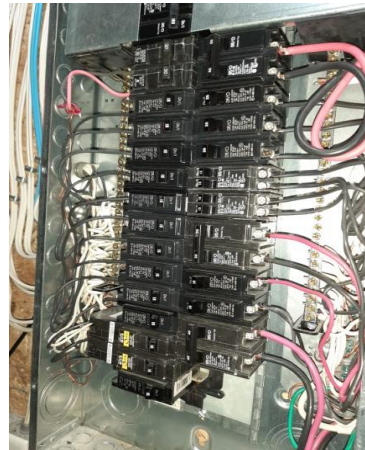
SERVICE PANEL: **overall in good repair**

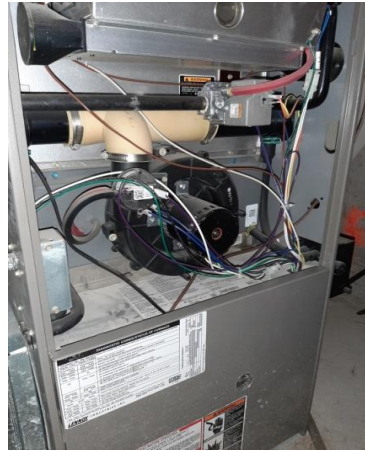
FORCED AIR FURNACE: [service annually](#)
Filter: [replace 1-per-3 months](#)

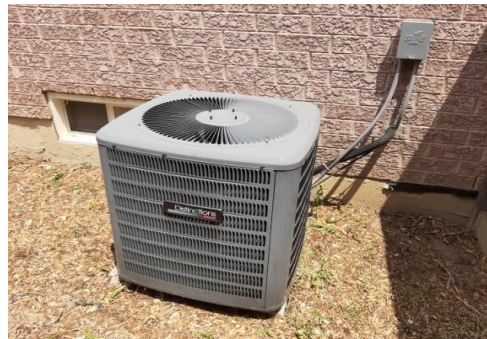
AIR CONDITIONER: [service annually](#)

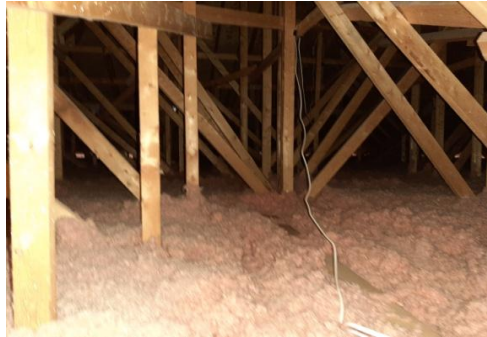
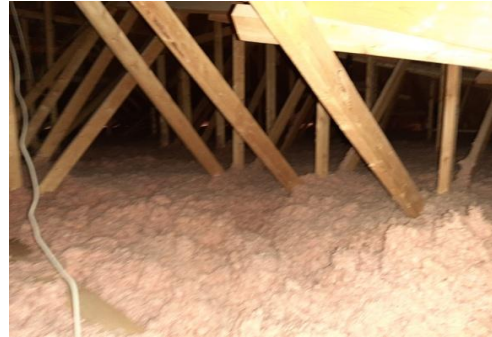
ROOF SPACE: insulation and ventilation is adequate

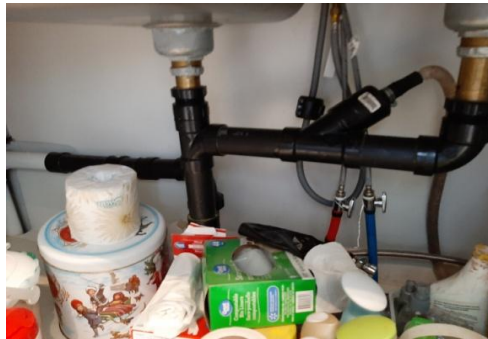
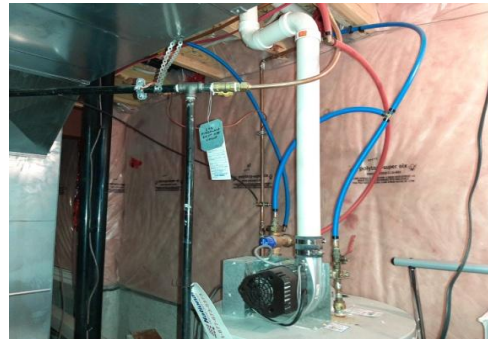
SUPPLY PIPING: all piping and connections examined were in good repair
 WASTE PIPING: all piping and connections examined were in good repair

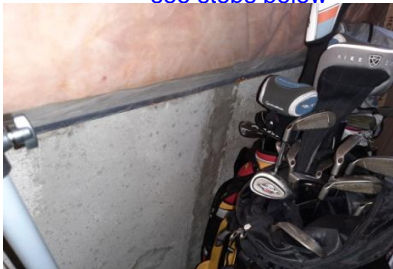
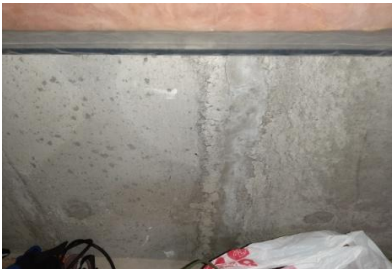
**Basement Leakage: typical staining in some areas of foundation where prior crack repairs, overall no signs of leaking
see steps below

- gutters, downspouts, grading, driveways: ongoing maintenance and repair/see Exterior
- cracks/form ties on foundation: monitor/repair as required
- excavation/damp-proofing: monitor basement, consider step 3 as a last resort
